# FIRE JOURNAL

MAY 1968 VOLUME 62, NO. 3

# Fire Journal

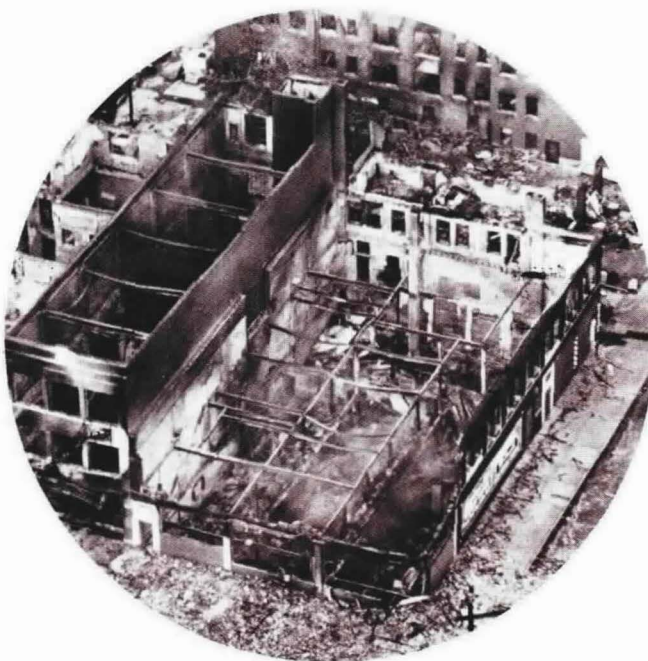
*Fires set by rioters presented new fire-fighting problems in many cities. This burned-out block of apartment houses and business establishments in Detroit, Michigan, shows the extent of damage inflicted in some of the riot-torn areas.*

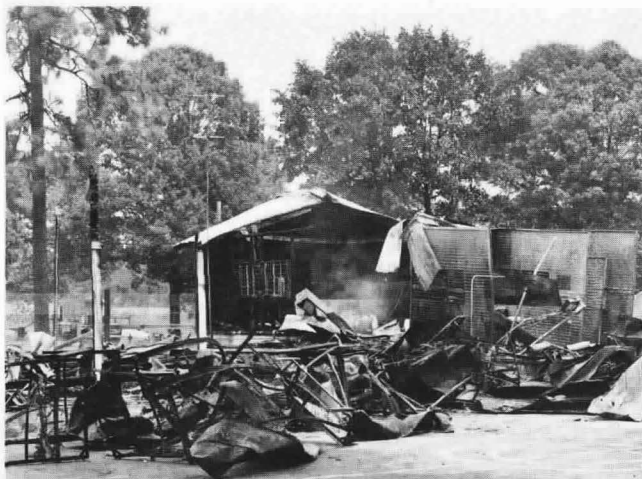
*A fire started by prisoners during a riot quickly consumed this wooden prison barracks in Berrydale, Florida, leaving 38 prisoners dead — the largest loss of life in a single fire in the United States or Canada in 1967. The metal cage in the foreground was the guard station.*

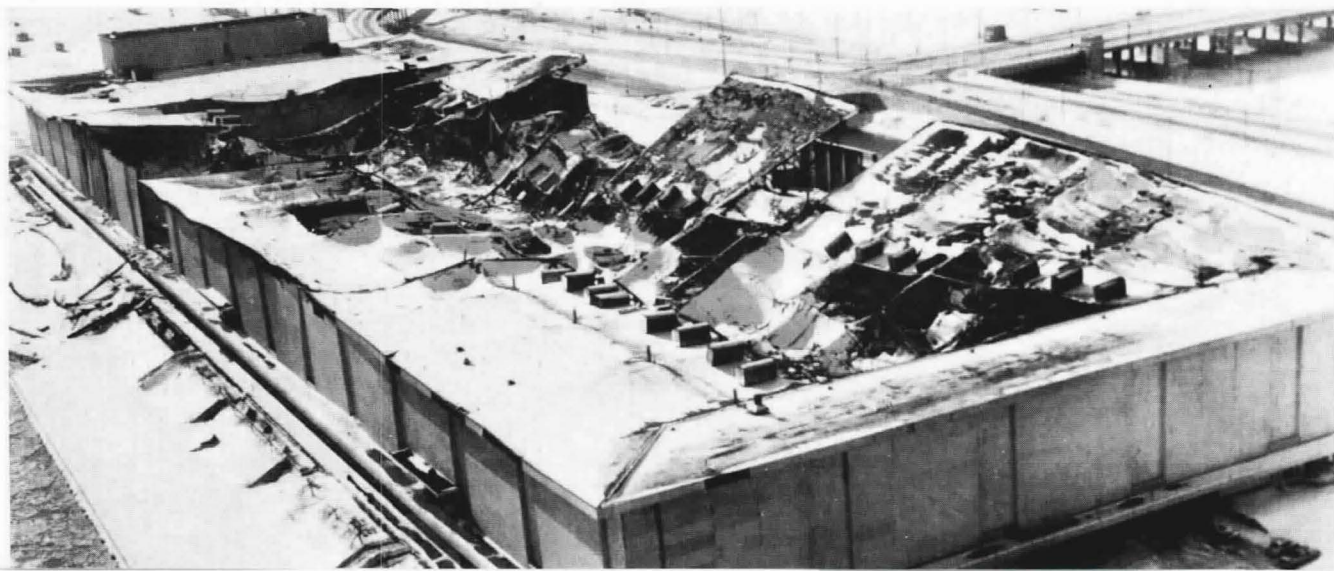
*Chicago's huge McCormick Place exhibition hall lies in ruins after the disaster distinguished as the worst property loss to a building from fire in history. The unprotected noncombustible building, thought by some to present no particular fire hazard, on January 16 suffered damage of \$52,500,000.*

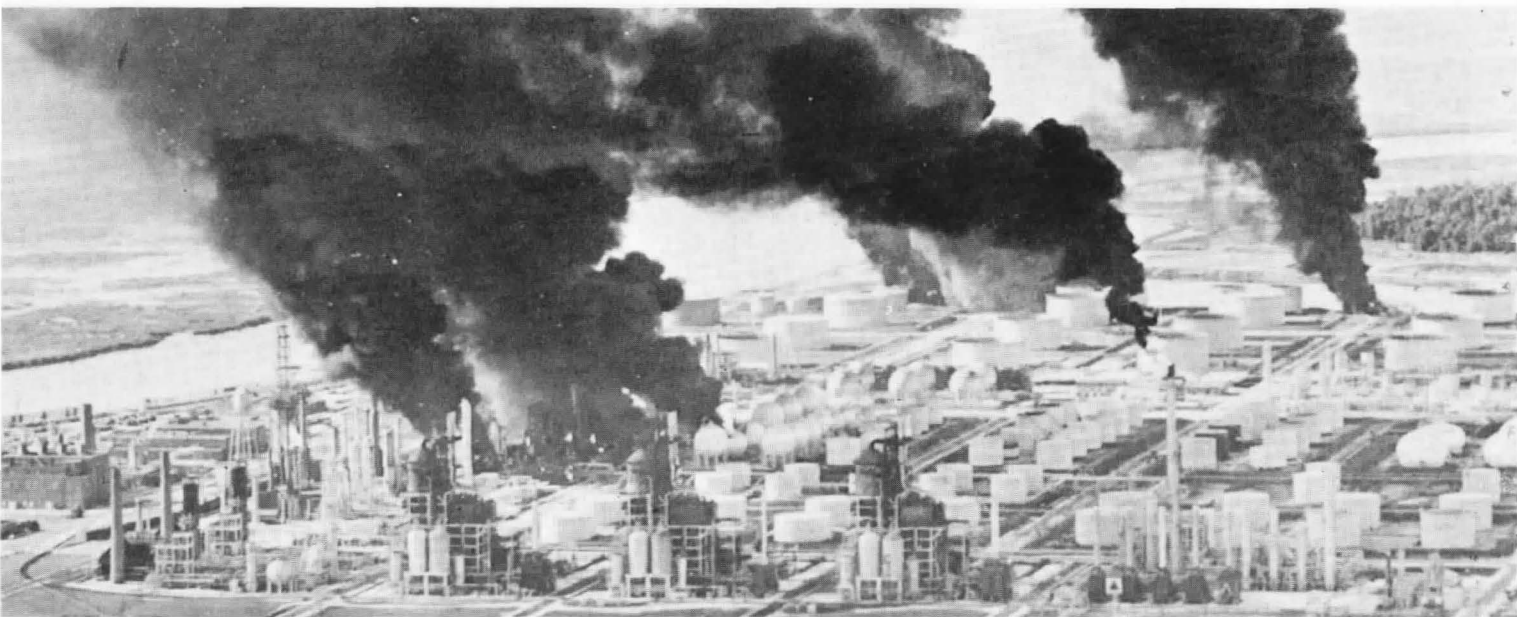
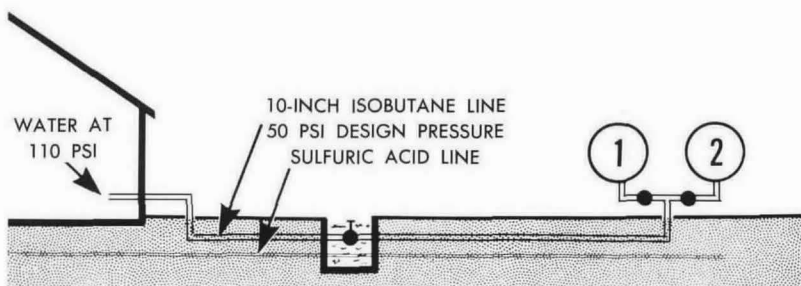
*The above aerial view of the Cities Service refinery, Lake Charles, Louisiana, gives an idea of the size of the complex. The \$20,-500,000 fire on August 8 began with an explosion in the area shown burning at left. Secondary explosions caused other fires throughout the complex.*

had badly corroded because of vapors from a leaky sulfuric acid line that ran underground near by. On August 8 workmen saw bubbles in the water that covered the valve in the pit and realized that the valve was leaking. They proceeded to clear the isobutane line by flushing water at 110 psi through it from the alkylation unit to Sphere No. 1 (see the diagram above). When a workman had determined that the isobutane had been flushed from the line and that the line was filled with water, he closed the valve to Sphere No. 1 and started to open the valve to Sphere No. 2. The 110-psi water pressure against the closed valve at Sphere No. 1 caused the bonnet to fly off the weakened valve in the pit and a geyser of water to rise into the air. When the workman saw the geyser, he thought he had done something wrong and reversed his procedure, closing the valve at Sphere No. 2 and reopening Sphere No. 1. When he did this, the isobutane back-pressured from Sphere No. 1 and discharged from the damaged valve in the pit. An estimated 500 barrels of isobutane escaped to ignite explosively, killing seven workmen and starting a fire that burned for two weeks, until the fuel had been consumed. The property damage amounted to \$20,500,000.

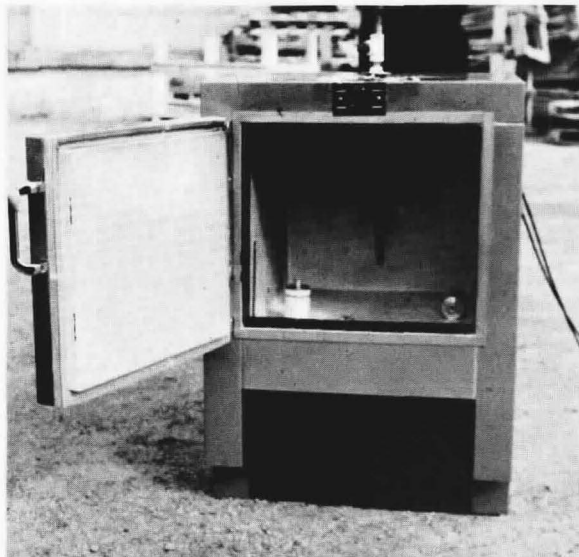
*The original refrigerator after three "explosions" of ethyl ether. The only visible damage is minor chipping of the porcelain inner door face.*

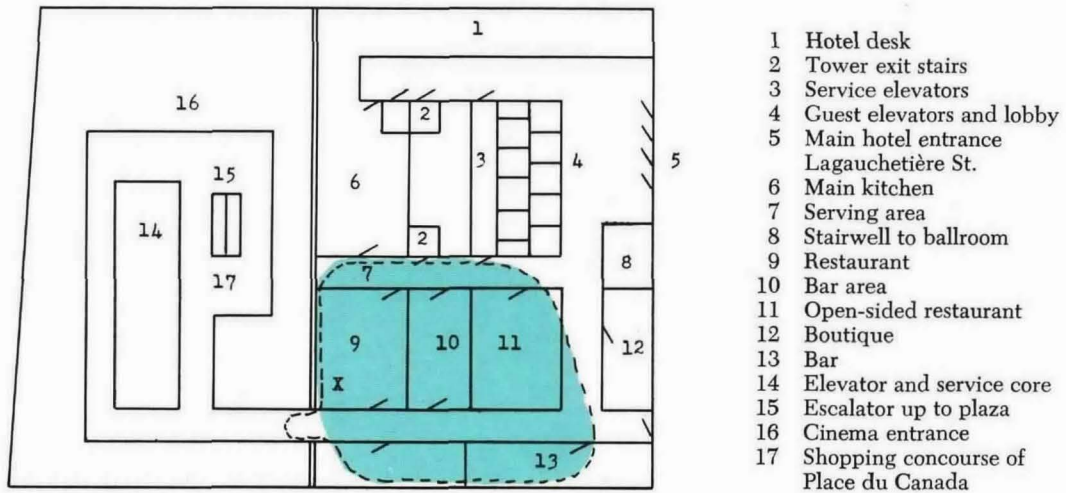
An approximate sketch plan, not drawn to scale, of the ground floor of Château Champlain — Place du Canada. The dotted line encloses the area of severe fire damage. The X marks the point where the fire originated.

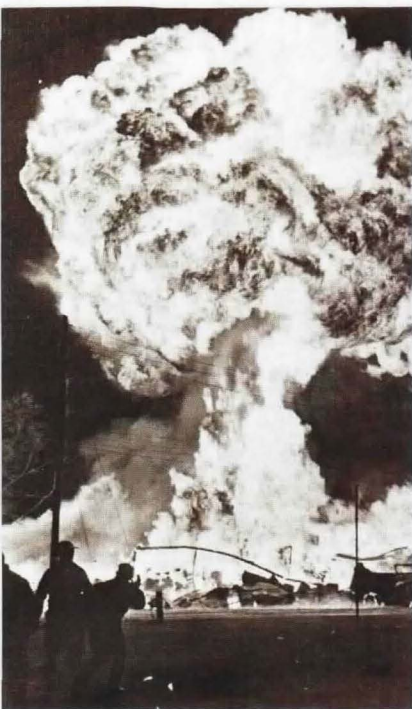
On March 4, 1966, this one-story wooden fruit packing-house in Elfers, Florida, burned to the ground, and with it a nearby dwelling and a restaurant. Five barrels of "separator oil" (used for separating dry from fresh fruit) ruptured in the latter stages of the fire, and the mushroom-like cloud of flame and smoke shown here was the spectacular result. The cloud lasted but a few seconds and caused no additional damage. Much of the sudden release of heat was intercepted and absorbed by smoke particles.

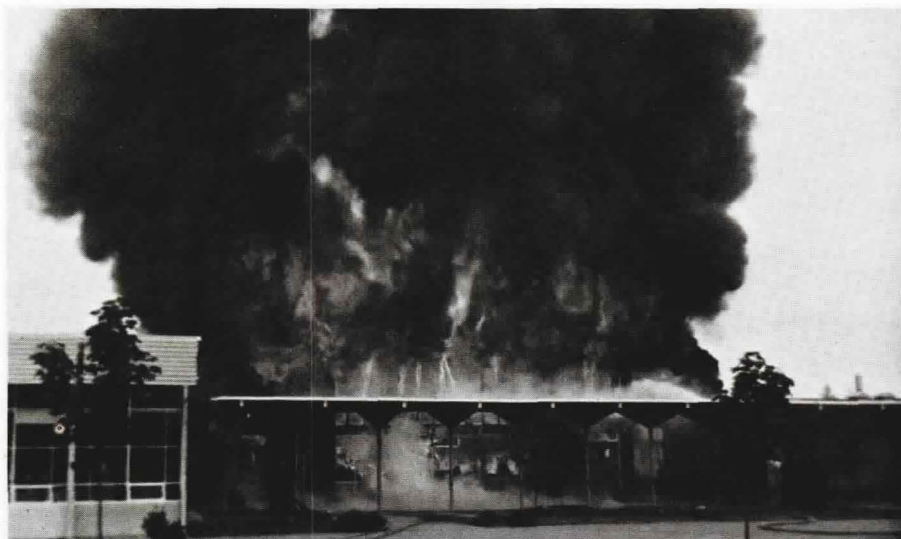
On August 5, 1963, this one-story wooden elementary school in Bellevue, Washington, was heavily damaged by a fire that started at a light fixture in the combustible ceiling tile. The flames dropped to the wooden furnishings below and also broke through the wooden roof. The height of the building varied from 25 feet in the front to 16 feet in the rear. Burning studs of the building front are visible rising above the level of the roof of the low structure in the foreground (not involved in the fire). The height of the flames above the tops of the studs appears to be over 25 feet.

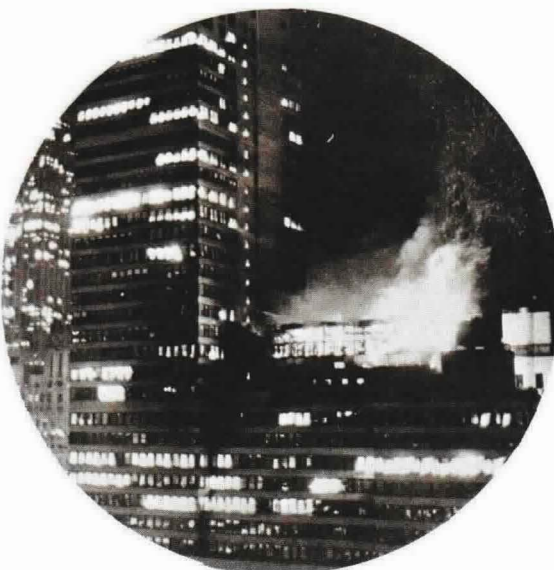
This fire on June 2, 1967, in San Diego, California, destroyed only one-quarter of the two-story (35-foot-high) furniture store. Flames above the roof reached a height of approximately 20 feet before the Fire Department established control. The fire started at a loading dock, entered the wooden building, and spread upward by way of an unprotected wooden staircase. It is estimated that the fire burned one hour before discovery. If much more time had elapsed, the flames would undoubtedly have reached higher above the roof.

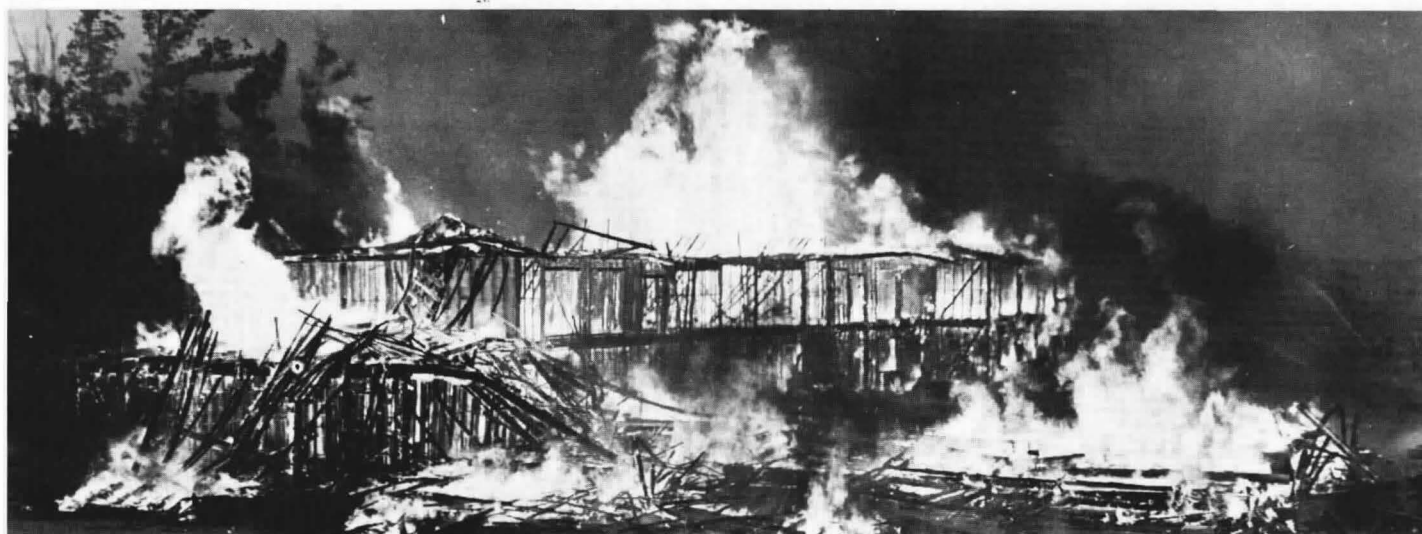
*Above: This two-story apartment house of wooden construction in Hampton, Virginia, had not quite been completed when a fire of undetermined cause destroyed it on August 25, 1965. High wind and lack of nearby hydrants were factors. The flames extended the equivalent of two or two and a half stories above the roof line.*

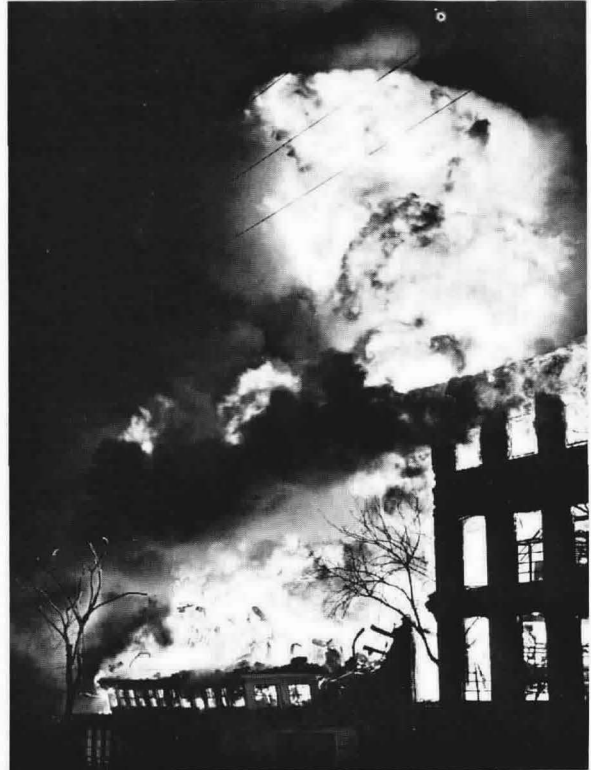
Right: Woonsocket, Rhode Island, April 29, 1967. A four-story (50-foot-high) worsted mill ablaze on all four sides, with the flames from the roof equivalent in height to more than three stories. The plant was of mill construction and processed both wool and synthetic yarns. The fire, which started in the first floor from malicious use of gasoline, resulted in rapid spread of flames that overpowered the sprinkler system. Because the vertical cutoffs were incomplete, the fire soon spread to the upper stories. By the time the picture was taken, the first story had been practically burned out.

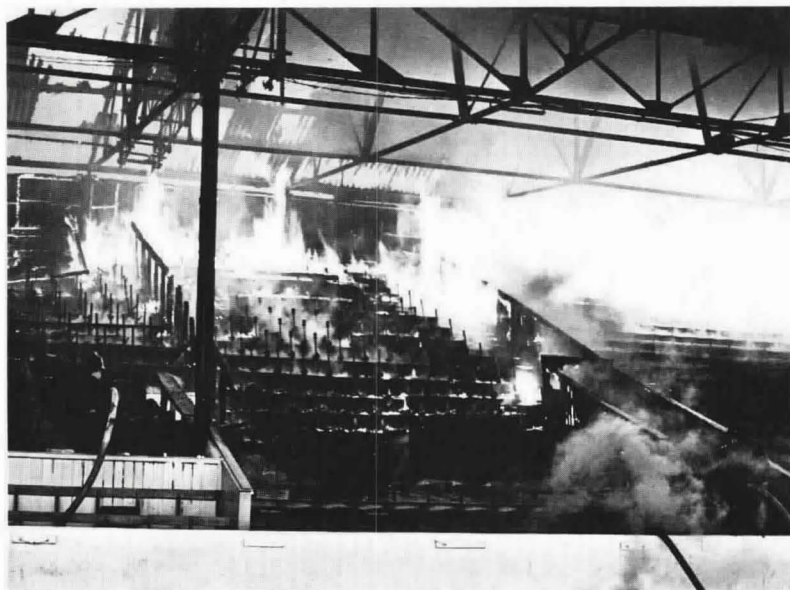
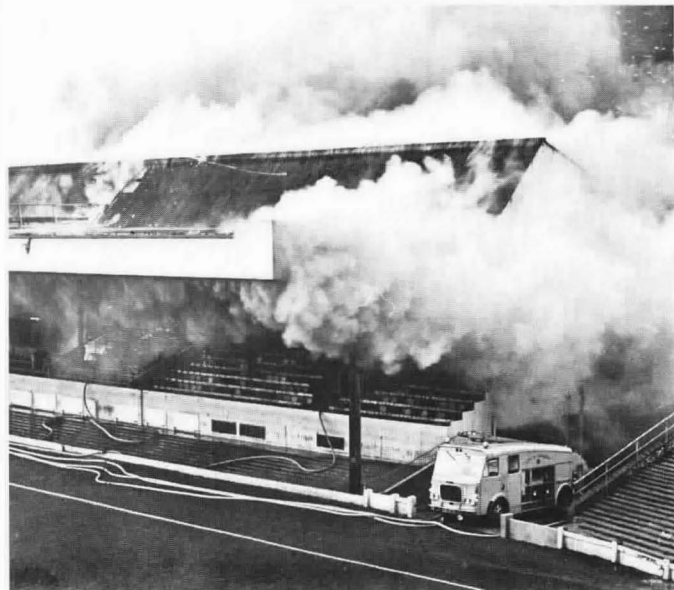
*A carelessly discarded cigarette that ignited an upholstered chair was the probable cause of a fire that destroyed one-third of the 2,500-seat stands at the Coventry City Football Club, March 6, 1968. Most of the administrative offices, clubrooms, and dressing rooms occupying the two levels below the seats were also destroyed. The fire had made great headway before discovery by a passer-by at 7:00 am. The fire is believed to have originated in a small ground-floor clubroom occupied for a social gathering until 2:30 am.*

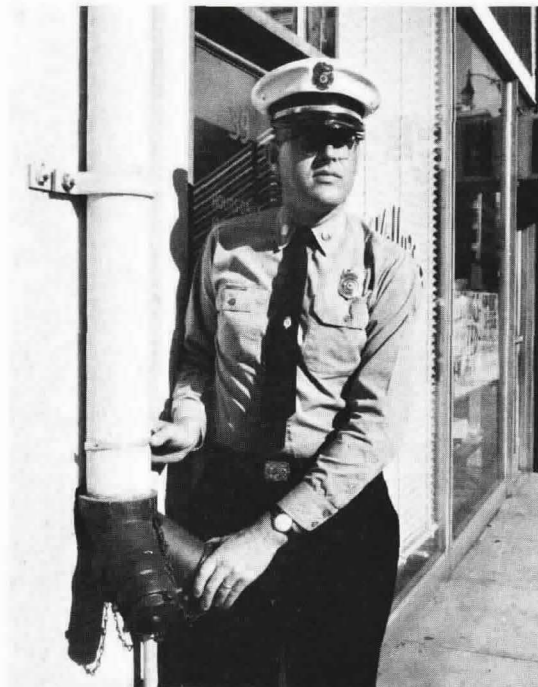
*An inspector examines a new standpipe where the old standpipe had failed completely. The old standpipe, encased in the brick veneer of the building, ruptured in the pressure test. The building management decided that it would be less expensive to install a new standpipe than to remove the brick façade and repair the old pipe.*

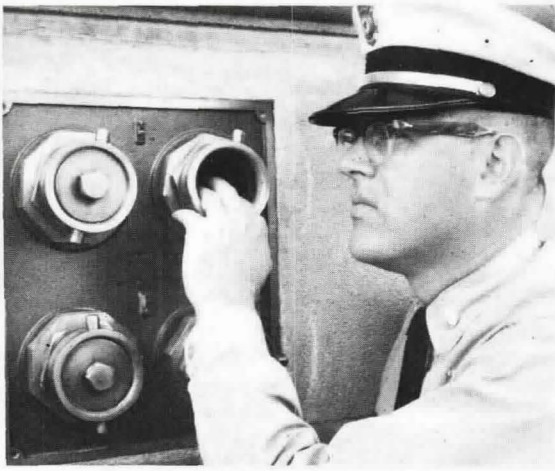
*Above left: This Fire Department connection blew out of the wall under test pressure. During the original construction workmen had engaged only the first thread holding the connecting pipe nipple in place.*

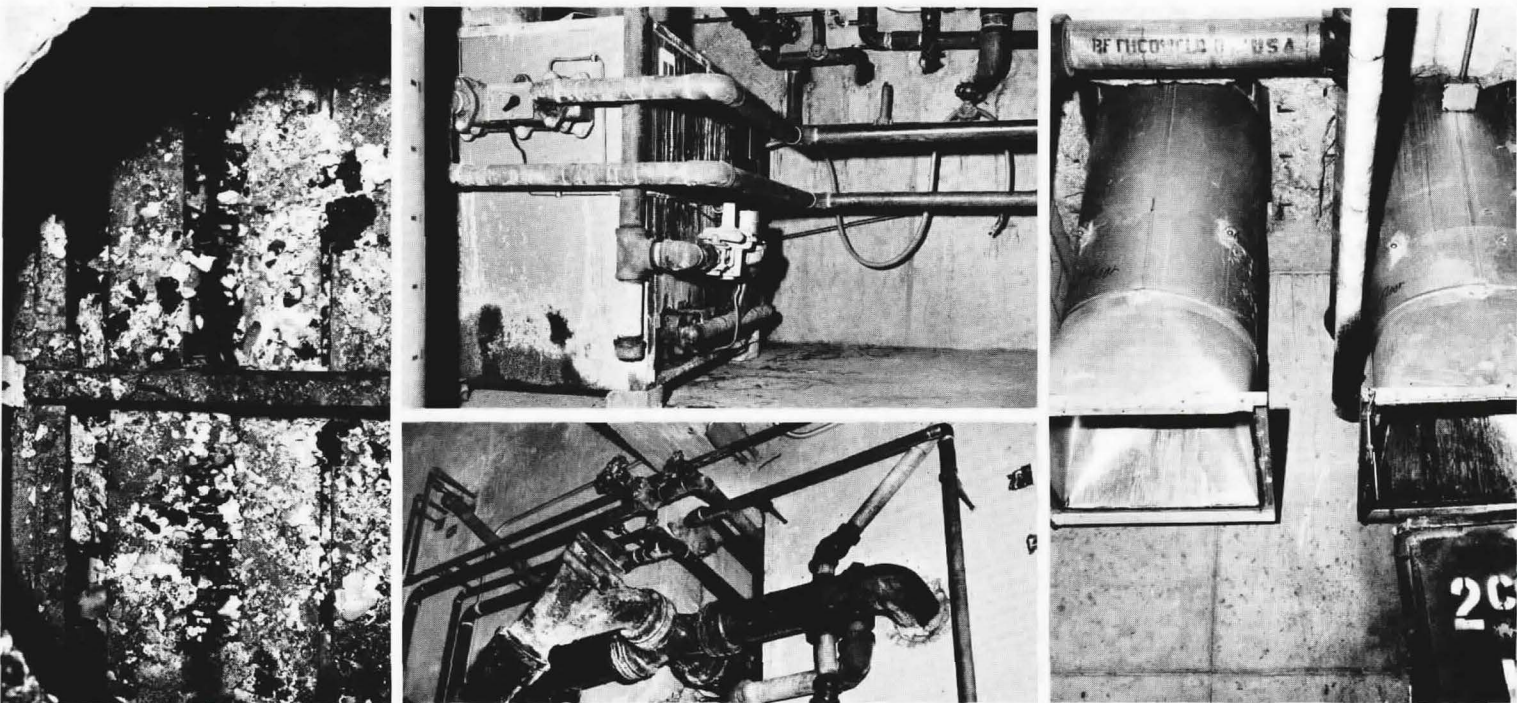
*Left: This photo was taken looking directly into the vent opening in the top of the heater after the vent pipe had been removed. The accumulation of residues was caused by excessive condensation of water containing carbon dioxide and particulate matter and subsequent evaporation of the water. The top and sides of the heater gave evidence of the same condition.*
