# FIRE JOURNAL

MAY 1968 VOLUME 62, NO. 3

# Fire Journal

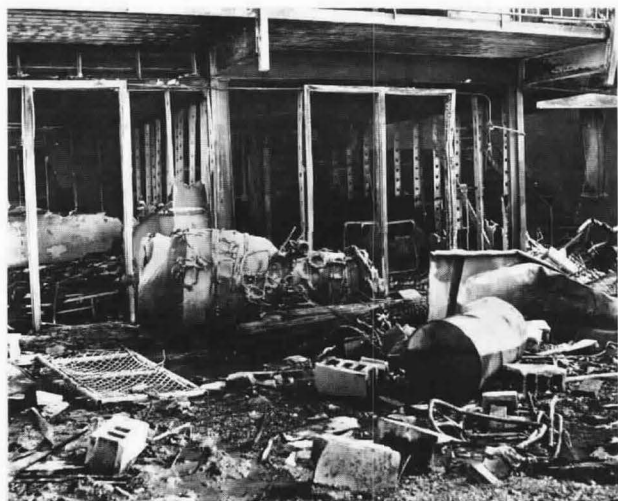
*A jet engine and other debris from the DC-8 aircraft that crashed into a motel in Kenner, Louisiana, after fire-fighting operations were completed. Nine guests in the section of the motel in the background were among the 13 people killed in the ensuing fire.*

was banking for his approach to the airport when the crash occurred. The aircraft apparently struck the ground and crashed through two private homes before cartwheeling into the motel, where it broke up and burned. The building damage amounted to \$647,200. The aircraft damage was due primarily to impact.

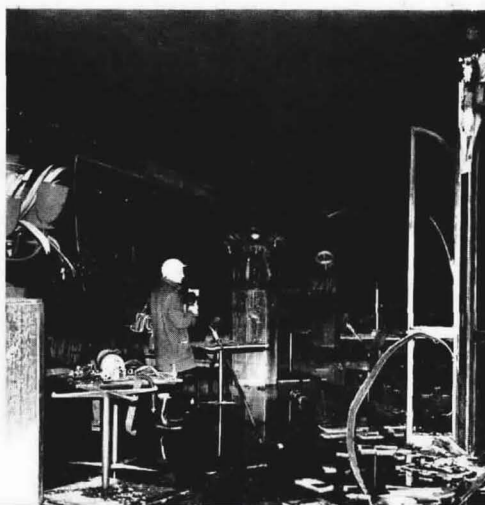
*Center: The restaurant adjoining the lobby with half wall. Note the melted plastic shrubbery running down the wall.*

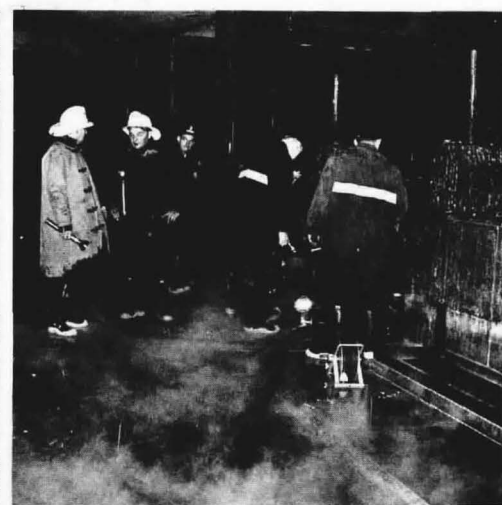
*Right: Here the fire stopped, at a point adjacent to the lobby, where fire streams could reach it in early stages. GAZETTE PHOTO SERVICE*

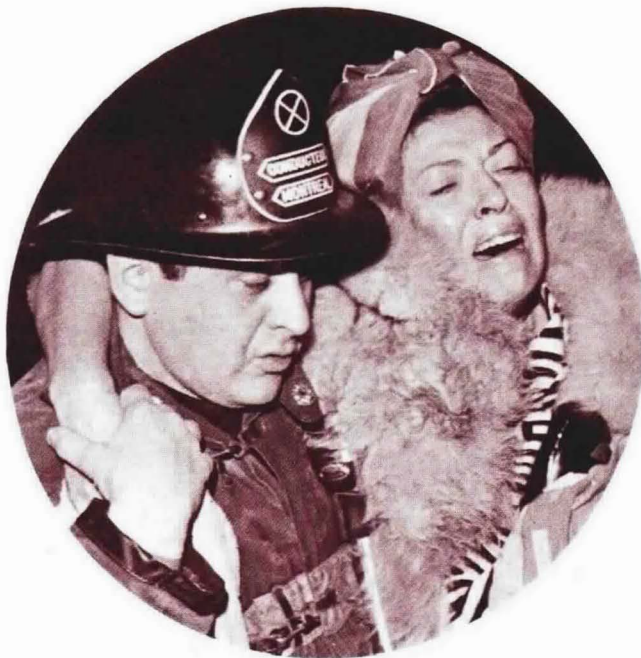
*A guest emerging from the smoke-filled lobby of the hotel. Some guests had to be carried.*

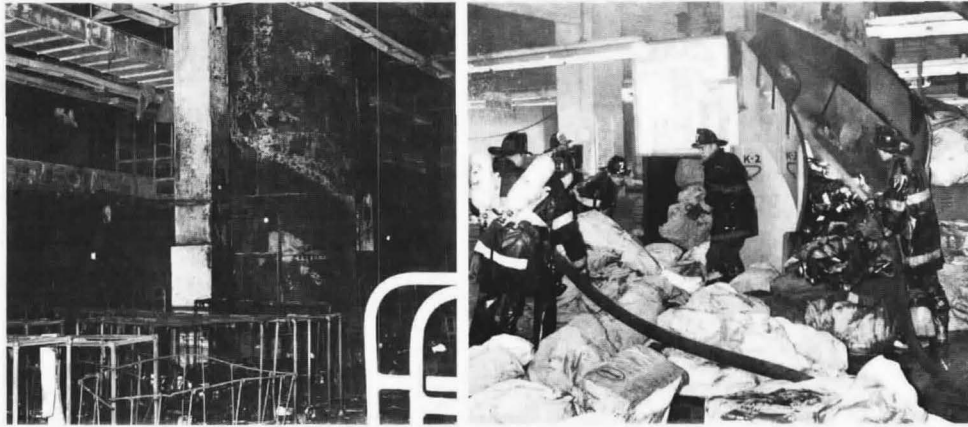
*Spiral chutes were used throughout the building to move mail bags from the upper stories to floors below. Here we see one such chute, which ran from the fifth story to the first story: left, where it passed through the third story, and, right, where it emptied on the first story.*

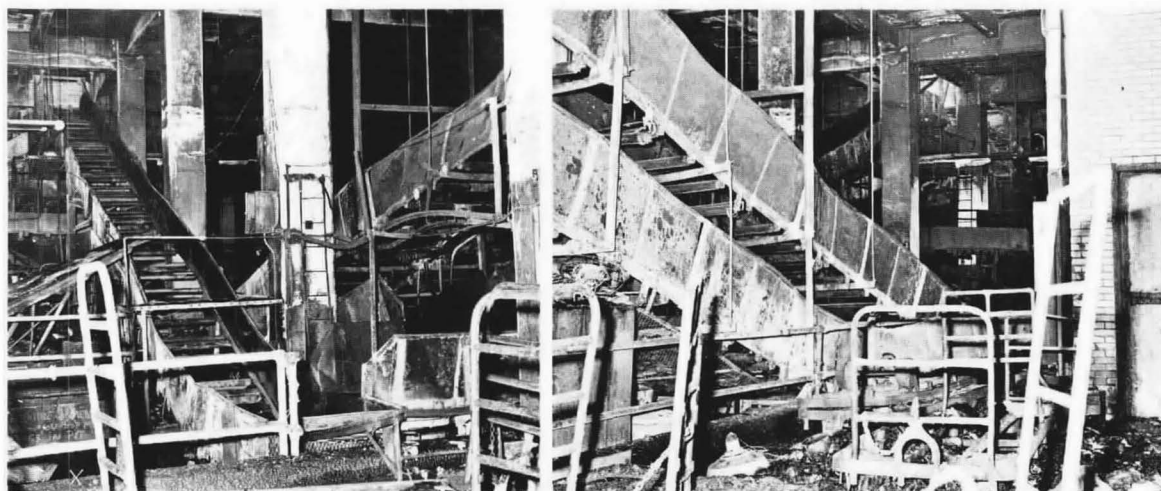
*Taken on the second story, these two photos show typical conveyer equipment used throughout the building. Left: Mail was automatically transferred from one of the conveyers at right, coming from the basement, to the conveyer at left, for distribution throughout the second floor. Right: Two of the conveyers pass unprotected through the second story to an upper story. All the rubber belts on the conveyers have burned away.*

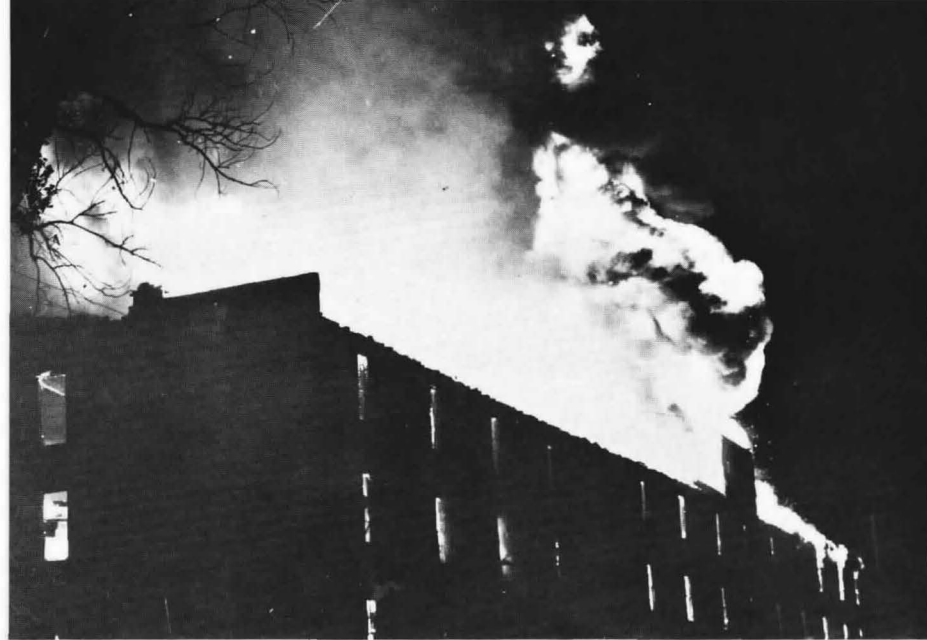
*Left: Electrical appliance assembly building fire of May 19, 1965, in Hannibal, Missouri. The fire started in the second story of the four-story building of ordinary construction and involved the upper three stories. The sudden burst of flame at the right of the picture was probably caused by the release of flammable liquids. For most of the roof area the flames do not extend much more than 20 feet high. The building is 45 feet high.*

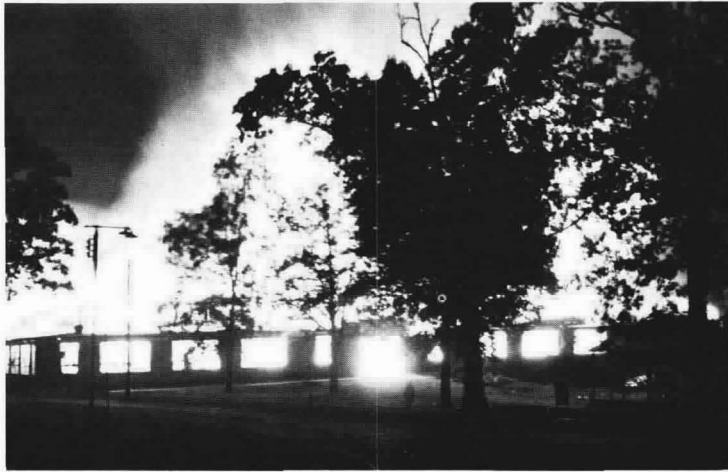
Above: Fairgrounds exhibition building fire of September 7, 1960, in Springfield, Missouri. The 12- to 20-foot-high wooden building with stone walls contained wooden bleachers and dry tanbark on the floor. The concentration of combustibles led to a huge fire in the isolated location, spreading to barns 30 to 60 feet away. This photo illustrates the difficulty in determining the exact height of flames when there is reflection from smoke rising from the fire. The flames, however, did extend much higher than in the average fire considered in this study.

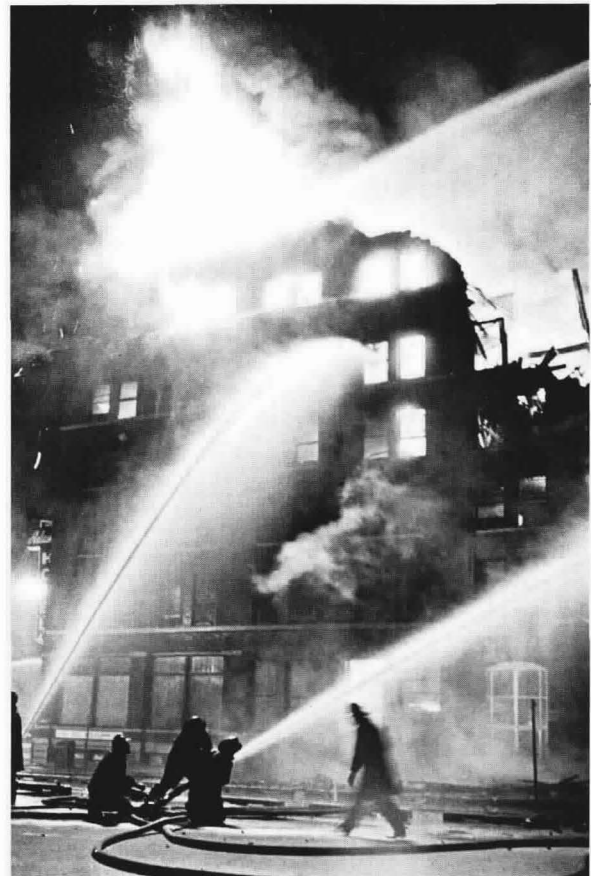
Bottom: Hotel fire of August 11, 1963, in Flint, Michigan. The fire started on the third story of the six-story (72-foot-high) hotel of ordinary construction and involved chiefly the four upper stories. After rescuing all but three of the occupants, the fire department used many large hose streams, but despite their efforts flames extended approximately three stories above the roof.

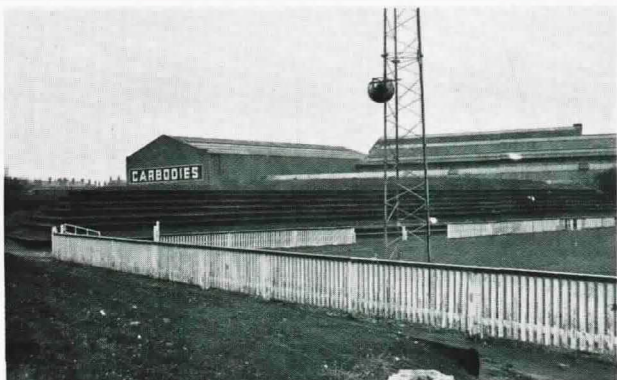
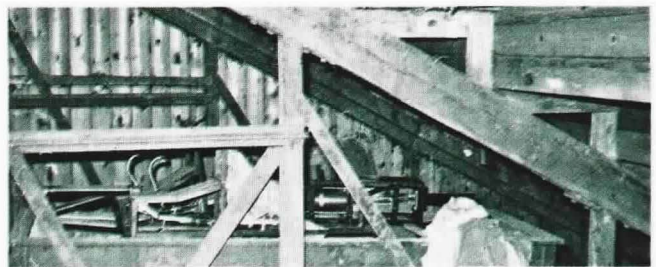
Above and left: two examples of combustible rubbish below timber stands.

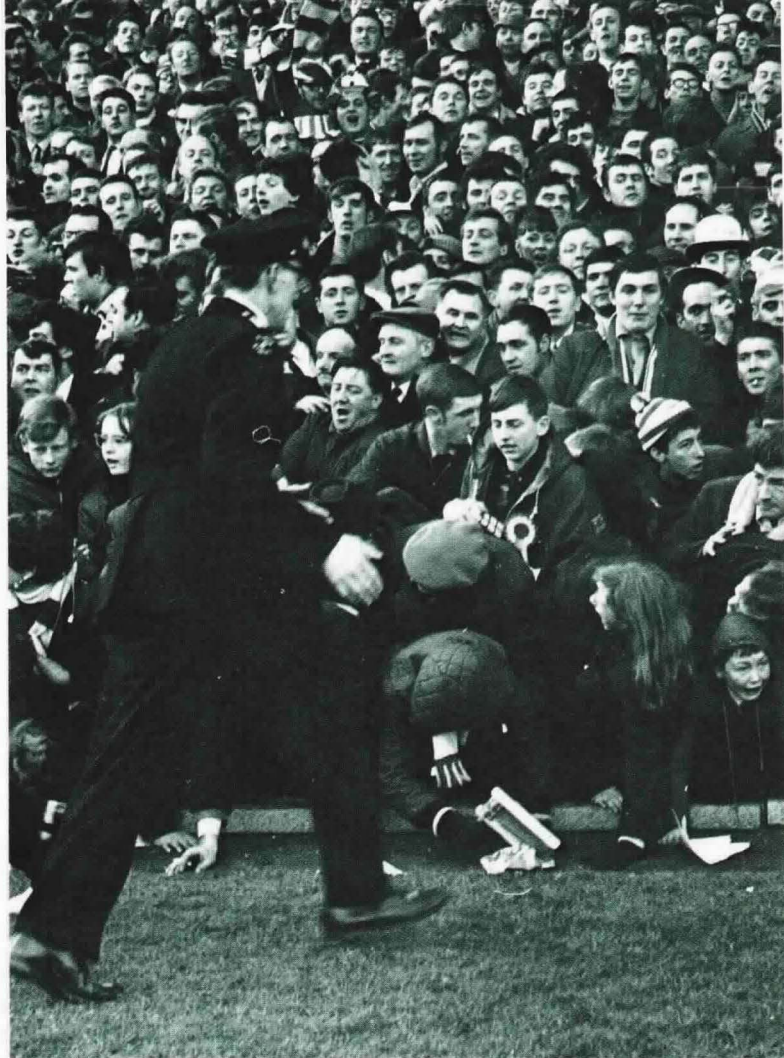
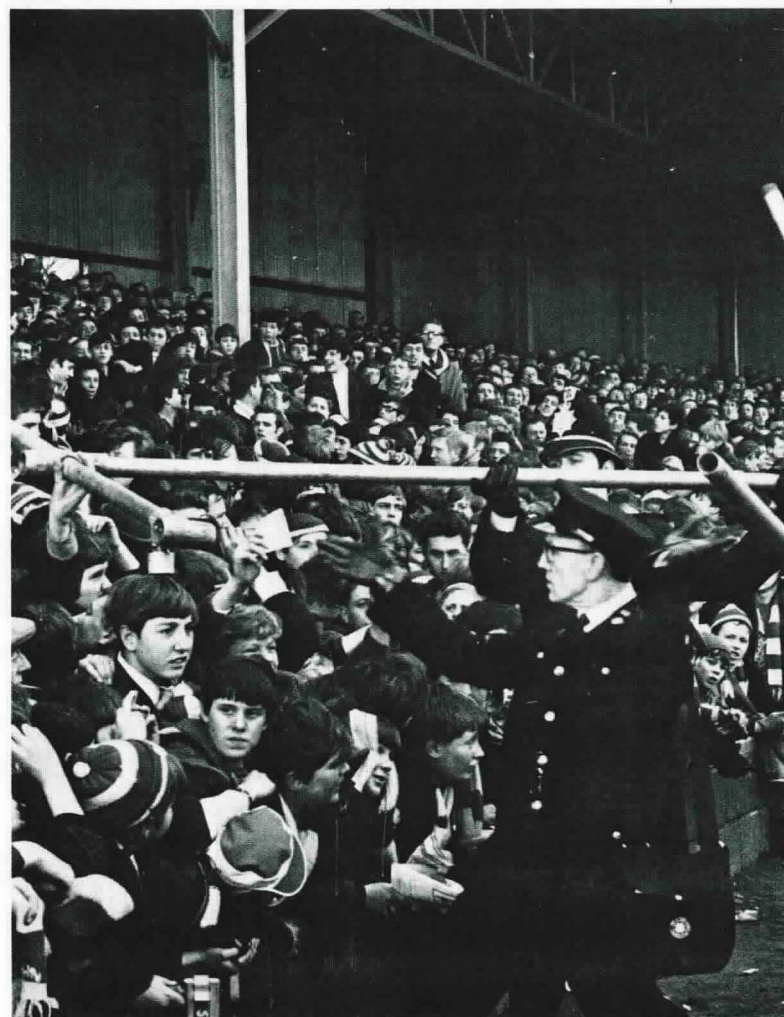
Right, top: At this Midlands match on February 17, 1968, the barrier collapsed and children were injured. In the lower photo, taken at the same match, we see the tubular steel barrier broken by the swaying crowd.

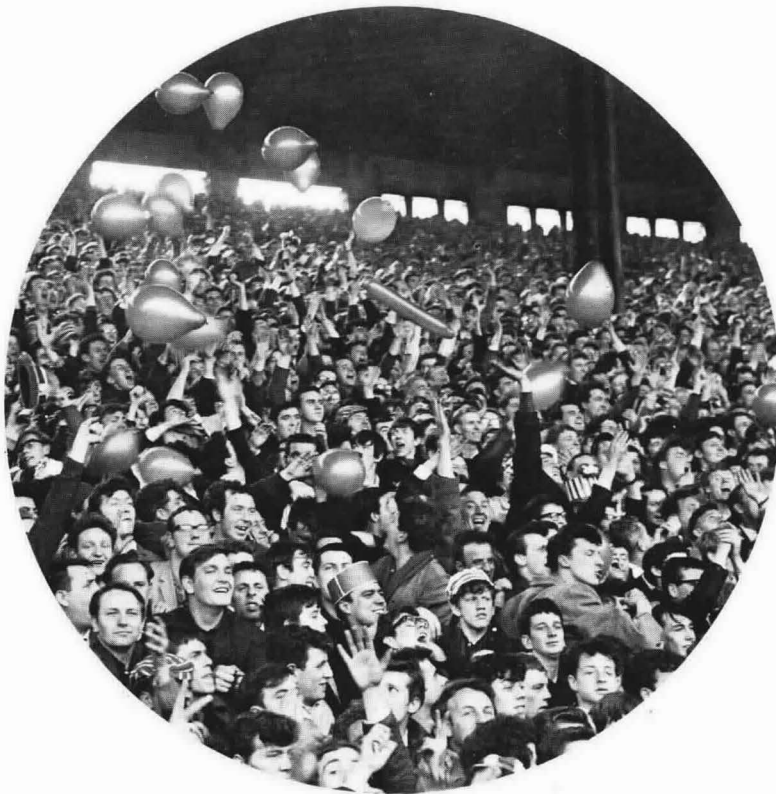
*A typical spectator crowd blocking gangways. As is obvious, the stands are uncompartmented. Crowds have been known to sway a distance of 40 feet.*

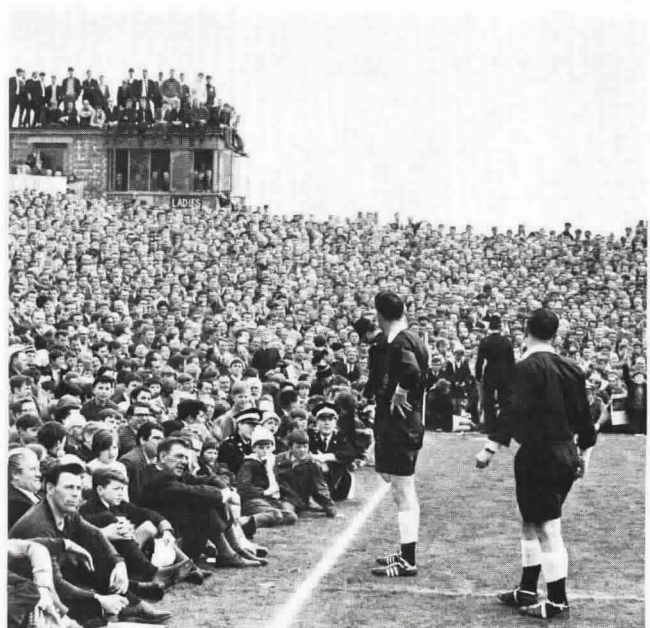
*A typical jammed-in crowd on terrace. Here the spectators forced into the field and the game was stopped.*

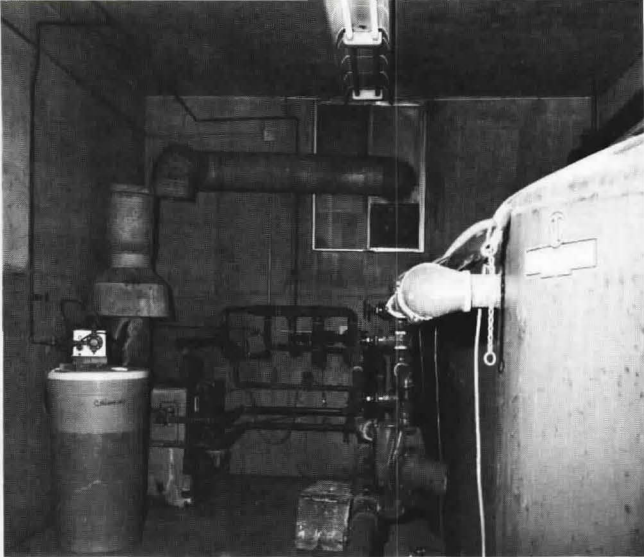
*Top of page: A view of the south end of the heater room. The pool heater and the chlorinator are at left. The filters are to the right. The vertical section of the vent pipe, including the draft hood, has been disconnected and moved to one side. The rectangular screened opening just below the vent wall penetration is the outside-air intake louver. The manifold and valves on the wall control the flow of the swimming pool water either through the heater or past it.*

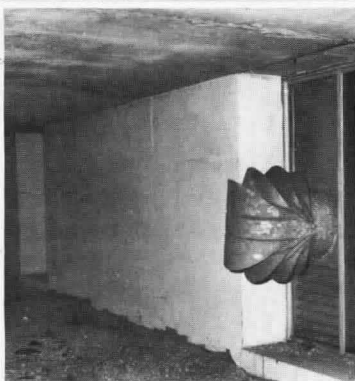
*Above: The vent cap, directly outside the heater room window and directly above the small fresh-air intake louver. The distance from ground to overhang is about five feet.*

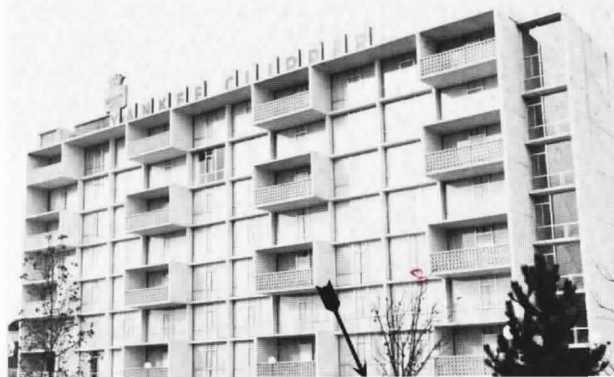
*Besides the seven-story guest-room building shown here, the motor hotel had a three-story guest-room building. The pool, in the left foreground, was located between the two guest-room buildings, which were joined at one end by a one-story building containing the offices, the lobby, and function rooms. Only the seven-story building was involved in the incident. The pool heater vent terminated beneath the ornamental overhang at the window (indicated by the arrow).*
